# USING ASD TO MITIGATE CO<sub>2</sub> METHANE AND BENZENE

Bill Brodhead
WPB Enterprises, Inc. 2844 Slifer Valley Rd., Riegelsville, PA 18077
wmbrodhead@hotmail.com

Over the last few years, WPB Enterprises has been contracted to reduce CO<sub>2</sub> in a number of residential buildings, methane in a commercial strip mall and benzene in a school building. Each of these has been successful mitigated. This paper will discuss the approaches taken with each of these gases and the results of the mitigations.

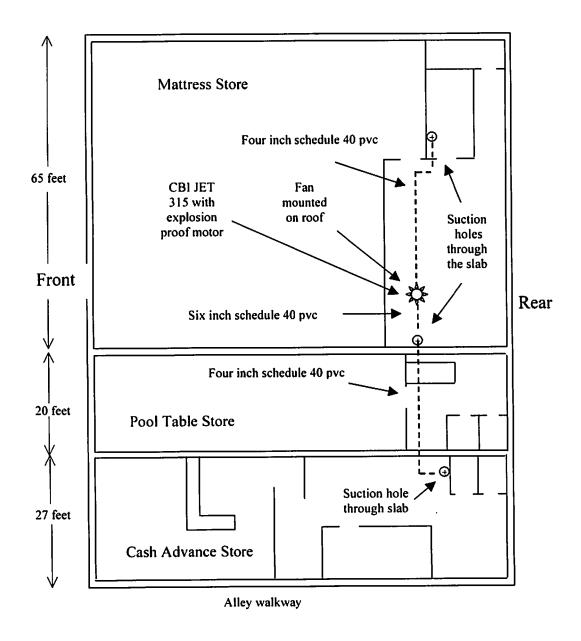
In the Fall of 2002, WPB made diagnostic measurements at the strip mall. A communication test was done by pressurizing the floor with a shop vacuum. A shop vacuum can become an explosive device if suction is applied to soil gas with methane in the 5 to 15% range. The communication test indicated that a single suction hole in the mattress store could produce a 2 to 6 pascal pressure reversal under the rear part of the store where the odors had been detected. There was only a slight pressure change from the mattress store to the cash store.

A three hole suction system was designed using an explosion proof fan installed on the flat roof. A CBI Jet 315 upblast exhaust blower with a 1/3 hp explosion proof motor was choosen for the fan. The local fire marshal was contacted to get approval for the fire-stop collars to be used as the vent pipe penetrated the firewalls between the stores. See the accompanying drawings.

In order to minimize the risk to store occupants and to the system installers, WPB installed the ASD piping and the roof mounted fan first. A new curb base was built on the roof and the CBI jet 315 fan installed. The electricians wired the fan the same day. The roofers flashed the roof the following week. After the roofers had completed the flashing, WPB used a wet diamond bit core drill to make all the suction holes through the slab. An environmental company was hired to make methane measurements during this phase of the work. There was 5000 ppm of methane in the pool table store back bathroom the day the final phase was completed (10% LEL). The main stores had very low levels of measurable methane in the air (0 to 500 ppm). The suction holes, after they were initially cut through the slab, had from 1400 to 2600 ppm of methane in the holes.

The final system performance indicated a flow rate of 570 cfm. The far cash store u-tube read 9/8 of an inch of water column. The exhaust on the roof had 2200 ppm of methane in the exhaust (4 % LEL).

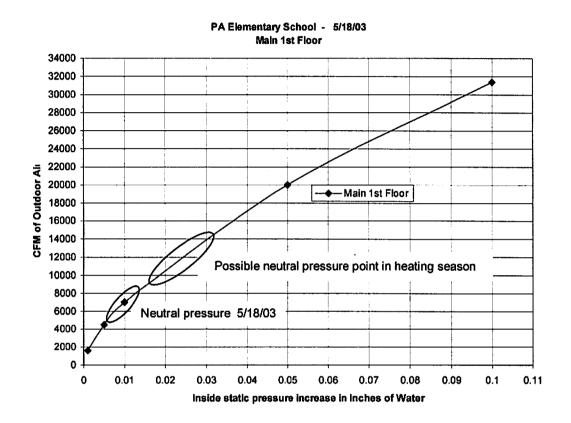
The blower doors indicated that it would require over 10,000 cfm of outdoor air to pressurize the main section of the building in the winter. The graph below indicates the amount of air needed to create pressure in the main portion of the building. The multipurpose room would require an additional 4000 cfm of outdoor air in the winter.

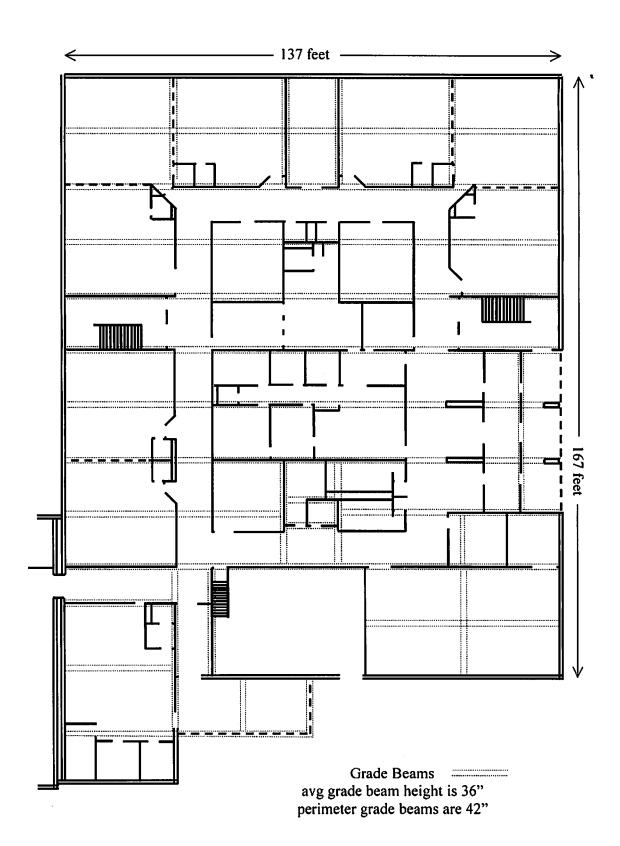
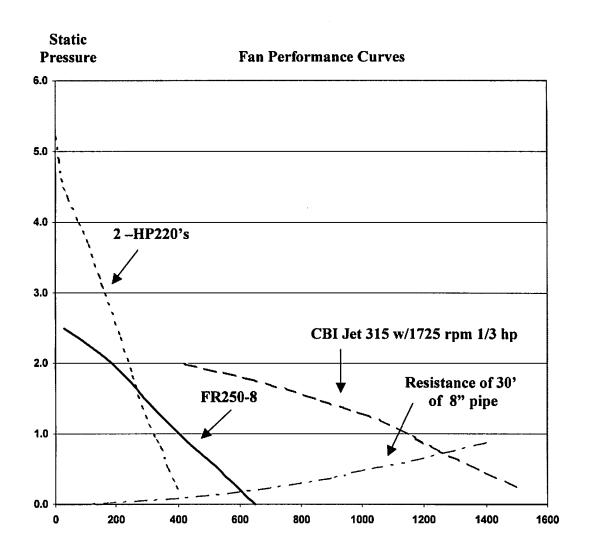
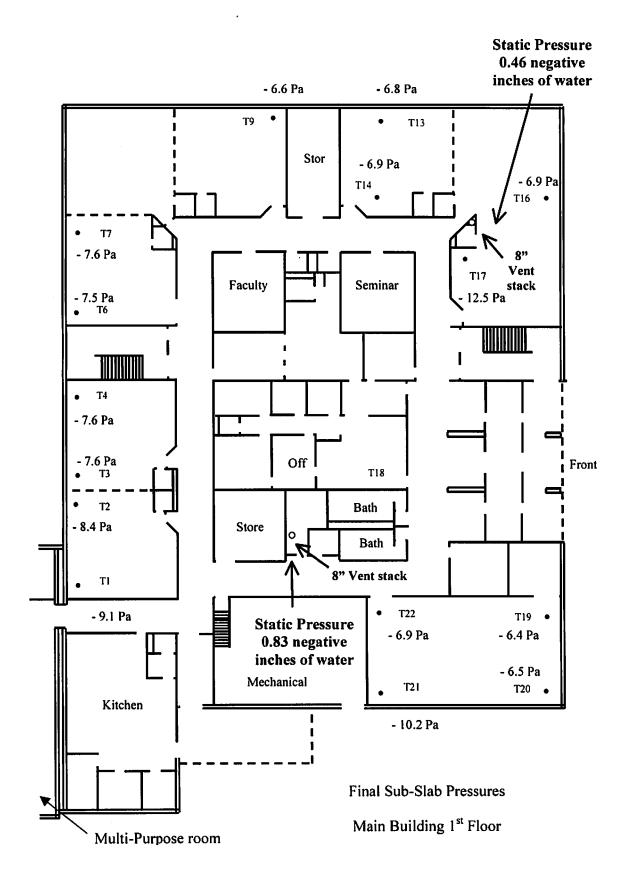
The Elementary School was constructed with a series of columns that support a network of grade beams. These grade beams are from 20 inches to 66 inches tall. The perimeter beams are mostly 42 inches high and 16 inches wide. The interior grade beams are mostly 36 inches tall. The beams are typically 16 or 20 inches wide with re-enforcing steel bars. Eight inch thick concrete plank flooring, with steel re-enforcing in the concrete ribs, was laid across this network of grade beams. A two inch cement coating was poured in place over the concrete planking. See the accompanying drawings.

It was initially unclear whether there was any communication between the grade beams. The construction of the school in 1980 included three eight inch stack pipes that were routed from the space between the grade beams to the roof. The main building had two eight inch stacks. The multi-purpose room had one eight inch stack. A curb based roof fan was installed on one of the main building eight inch stacks. WPB removed this fan and installed a CBI 315 jet fan in its place. The two remaining eight inch pipes had FR250-8 fans installed. The final sub-slab negative pressures are depicted in the final floor plan drawing below. These sub-slab pressures should be able to overcome the stack effect pressures down to 10 to 15 degrees of outside temperatures.
