# USING ASD TO MITIGATE CO<sub>2</sub> METHANE AND BENZENE

Bill Brodhead
WPB Enterprises, Inc. 2844 Slifer Valley Rd., Riegelsville, PA 18077
wmbrodhead@hotmail.com

Over the last few years, WPB Enterprises has been contracted to reduce CO<sub>2</sub> in a number of residential buildings, methane in a commercial strip mall and benzene in a school building. Each of these has been successful mitigated. This paper will discuss the approaches taken with each of these gases and the results of the mitigations.

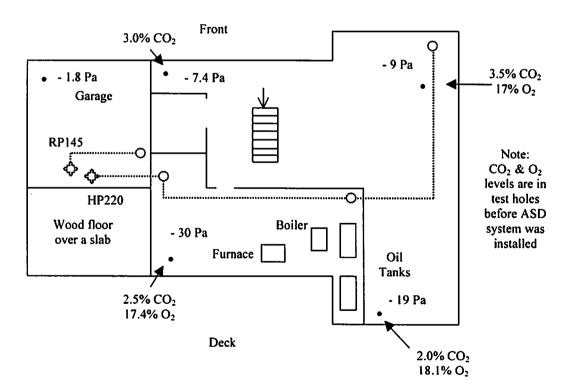
In December of 1999, WPB was contacted by the United States Department of the Interior, Office of Surface Mining, Reclamation and Enforcement about a house in Pottsville, PA that had elevated radon and CO<sub>2</sub>. The house was a 2500 square foot raised ranch that was only one year old. The radon levels were around 200 pCi/l, in the basement and 56 pCi/l on the first floor. The builder had installed a loop of perforated piping around the inside of the foundation footer in the gravel bed below the slab. The owner was initially complaining that the oil furnace would not function properly. The house is located in an area that contains old underground coal mines. The initial visit by the Office of Surface Mining found levels as high as 4% CO<sub>2</sub> near the floor of the basement with a dangerous level of only 17.1% O<sub>2</sub>. A butane lighter could not produce a flame as it approached the floor. CO<sub>2</sub> levels of 2% were found on the first floor and 1.5% on the second floor, even though the heating system was hot water baseboard. The house was ventilated until the oxygen levels returned to 20.8%. Within three days the levels in the basement had deteriorated to 17.7% oxygen. Office of Surface Mining maps indicated mining occurred just to the north and south of the home. It was unknown if bootleg mining (non-recorded mining) had occurred beneath the home.

Probe holes were drilled around the outside of the house to locate any bootleg mines. Layers of coal were approximately thirty feet below grade. No mine tunnels were found. When the drilling rig completed a test hole about twenty feet from the house closest to

the corner with the highest  $CO_2$  level (3.5%), hot air stated rising out of the shaft. The snow around the hole soon melted. The shaft was still fuming hot air a month later. Samples of the air were sent to a laboratory for analysis. The lab reported that the  $CO_2$  originated from newer wood than would have been coming from old mining timbers. It is suspected that there may have been large amounts of trees and brush buried at this location. The  $CO_2$  in the basement may or may not have been coming from this source.

Initially just an HP220 radon fan was installed. The CO<sub>2</sub> levels disappeared and the O<sub>2</sub> levels returned to normal on all floors. The radon levels, however, were still above the guideline at about 15 pCi/l. A second fan was installed and routed to a suction pipe in the garage floor. The second fan was an RP145. Both fans were installed in the garage attic and exhausted out the roof. All piping was four inch sewer and drain pvc. The "Pa" readings on the accompanying drawing are the final pressure readings in pascals at the test holes with both ASD fans operating. The HP220 basement system had a u-tube reading of 0.5 inches of water column and an airflow of 162 cfm. The final radon readings taken at the end of February 2000 were 0.8 and 0.3 pCi/l.

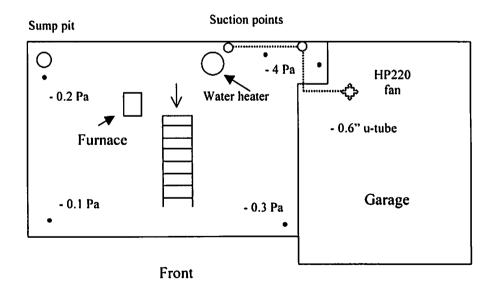
In Fall of 1999, a house in Pottsville, PA had trouble keeping the gas furnace and water heater going. The house was a new, two story, 1800 square foot, home with a full basement. The foundation walls were constructed of block. An investigation by the Office of Surface Mining found 2.5% CO<sub>2</sub> and only 16.7% of O<sub>2</sub> near the basement floor. Mining maps revealed an abandoned coal mine existed about 67 feet below the home.

The Office of Surface mining hired another contractor to seal the perimeter canal drain with non-shrink grout and all cracks with a special sealant. Subsequent measurements revealed that the CO<sub>2</sub> levels had decreased but were still present.

WPB was hired in March of 2000 to install an ASD system. The system used an HP220 fan with two suction points to maximize airflow. The final u-tube reading was 6/8 of an inch water column. This indicates airflow of about 160 cfm. No CO<sub>2</sub> was present after the ASD system was activated. Sub-slab pressures away from the suction holes were weak (-0.2 Pa) due to excessive airflow coming from the soil.

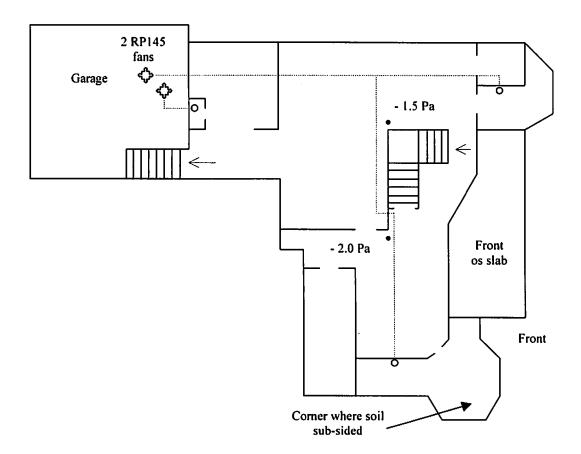
The house in Old Forge, PA was built in 1995. It is a two story 2500 square foot home with a finished basement. During the installation of the foundation, a corner of the excavation collapsed into an old mine tunnel. The Office of Surface Mining had the opening filled with concrete. In the following years the owners had problems with failure of gas pilot lights. In October of 2002 the owners reported the problem had worsened. An investigation by the Office of Surface Mining found CO<sub>2</sub> levels ranging from 1.5 to 1.9% and O<sub>2</sub> levels ranging from 18 to 19.6%. The owners were also complaining that the moisture levels in the basement were excessive.

A perforated piping system had been installed below the basement slab with a stub up, out of the slab, near the garage side of the basement. WPB was hired by the Office of Surface Mining to install an ASD system in January of 2003 that was to be connected to the stub up, in the slab and vented through the garage. A test hole was drilled in the center of the slab. The pressure under the slab was 5.0 pascals positive. When the HVAC fan came on, the pressure increased to 8.0 pascals positive under the slab. The HVAC was creating an additional 3.0 pascals of negative pressure. The return duct work in the basement could not be inspected for leaks because the basement was finished. A test fan was connected to the stubbed up pipe and this reduced the pressure under the slab by 1.5 pascals. The owner was very concerned about aesthetics and fan noise, so a single

RP145 fan was installed in the garage attic and the exhaust was routed through the garage roof. The u-tube reading was 6/8 of an inch water column. This indicates there is some resistance induced by the builder installed piping system. Even with the radon fan running, there was still a positive pressure under the center of the slab of 7.0 pascals when the HVAC air handler was running. Radon measurements made after the single fan installation averaged 40.3 pCi/l in the basement.

In May of 2003 a second RP145 fan was installed in the garage attic and vented through the roof. This time, two new suction points were installed. The piping to the suction holes was difficult because of the finished basement. The u-tube installed in the garage on this second fan system also read 6/8 of an inch of water column. This restriction was due to the long piping run to the two suction holes. An outside mounted fan system would have provided better system performance but the owner did not want the fans visible on the outside. This time with two fans running, the pressure under the slab in the center reversed to a negative 1.5 pascals. Some of this performance gain was due to the warmer conditions of May. The initial radon measurements with two fans running averaged 4.7 pCi/l. A second duplicate radon test done in June averaged 1.5 pCi/l.
