MEASURING AT-GRADE RADON MITIGATION EXHAUST

Bill Brodhead

WPB Enterprises, Inc., 2844 Slifer Valley Rd., Riegelsville, PA USA

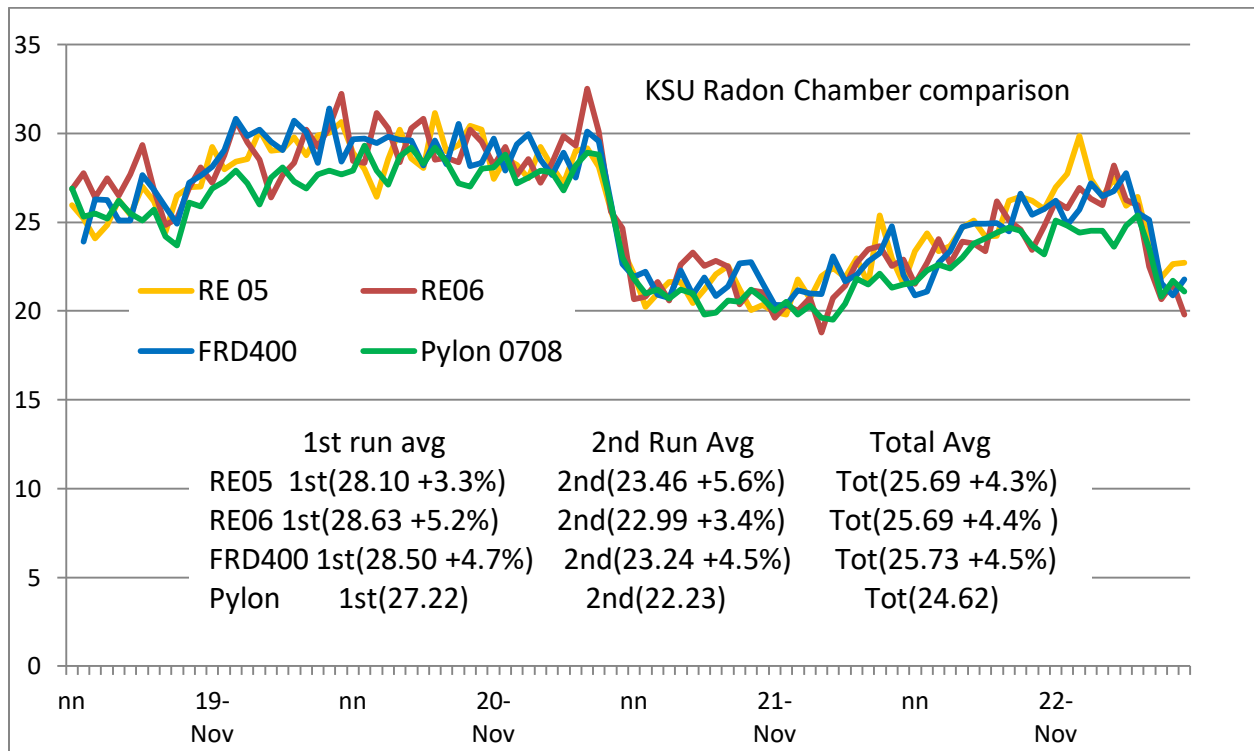
Figure 1: KSU Chamber Comparison

This study used eight FTLab Radoneye RD200 plus detectors, two FTLab Radoneye Pro detectors, one FTLab FRD400, one Airthings Corentium Pro and one Niton RAD7. The FTLab detectors were chosen for this study because their sensitivity made it possible to measure very low radon concentrations. See the consistence of the radon measurements in the author’s radon chamber at 4 pC/l in Figure 2. Prior to the start of this study the FRD400 was cross checked at the Kansas State University (KSU) radon chamber in November of 2019 using KSU Pylon #0708. Figure 1 shows the three FTLab detectors used in this study were averaging close to each other but about 4% to 5% biased higher than KSU measured chamber level. KSU chamber is part of the international COIRA chamber level comparison. The three FTLab units were subsequently adjusted by modifying their calibration factors to more closely match the KSU chamber level. These three units were used to set the calibration of the authors Pylon AB5 #578 that was too fragile to ship to a chamber. See Figure 2. All of the FTLab detectors used in the study were then compared to the adjusted FRD400 and each detector used in this study had its calibration factor adjusted to closely match the FRD400 measurements. The results of adjustments are displayed in the comparison tests in Figures 3, 4 and 5. Figure 6 displays the results of the Corentium Pro. It was decided to use the Corentium Pro to only measure the radon in

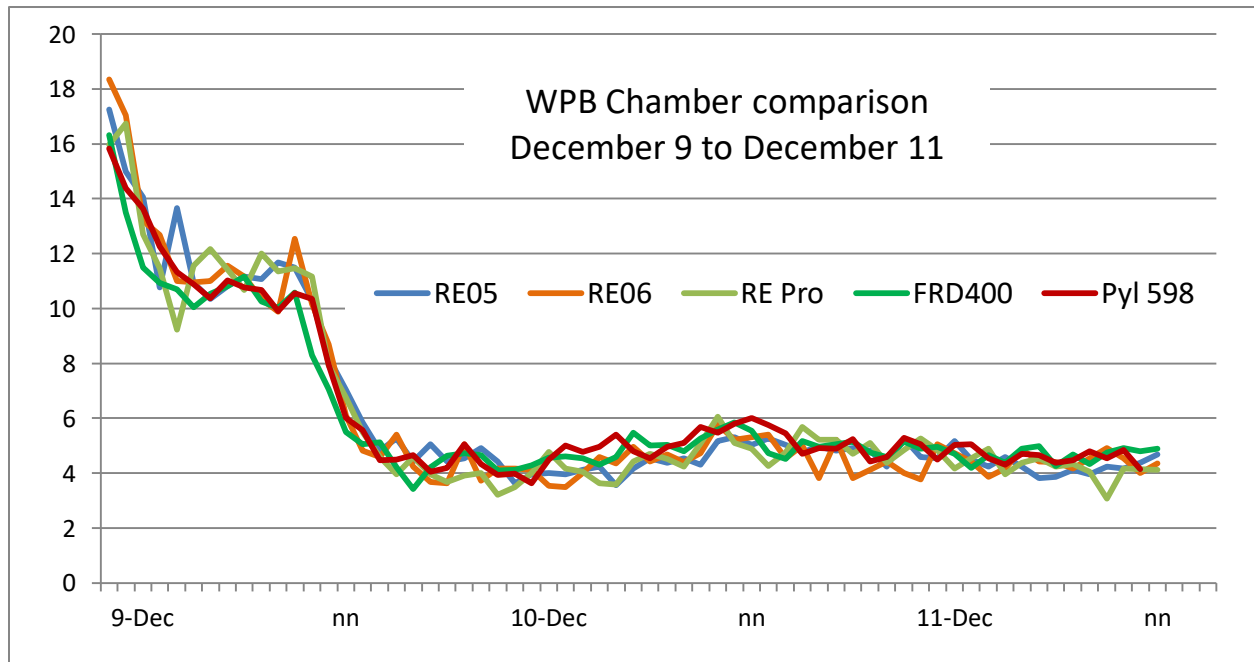
Figure 2: FTLab adjusted Detector Comparison

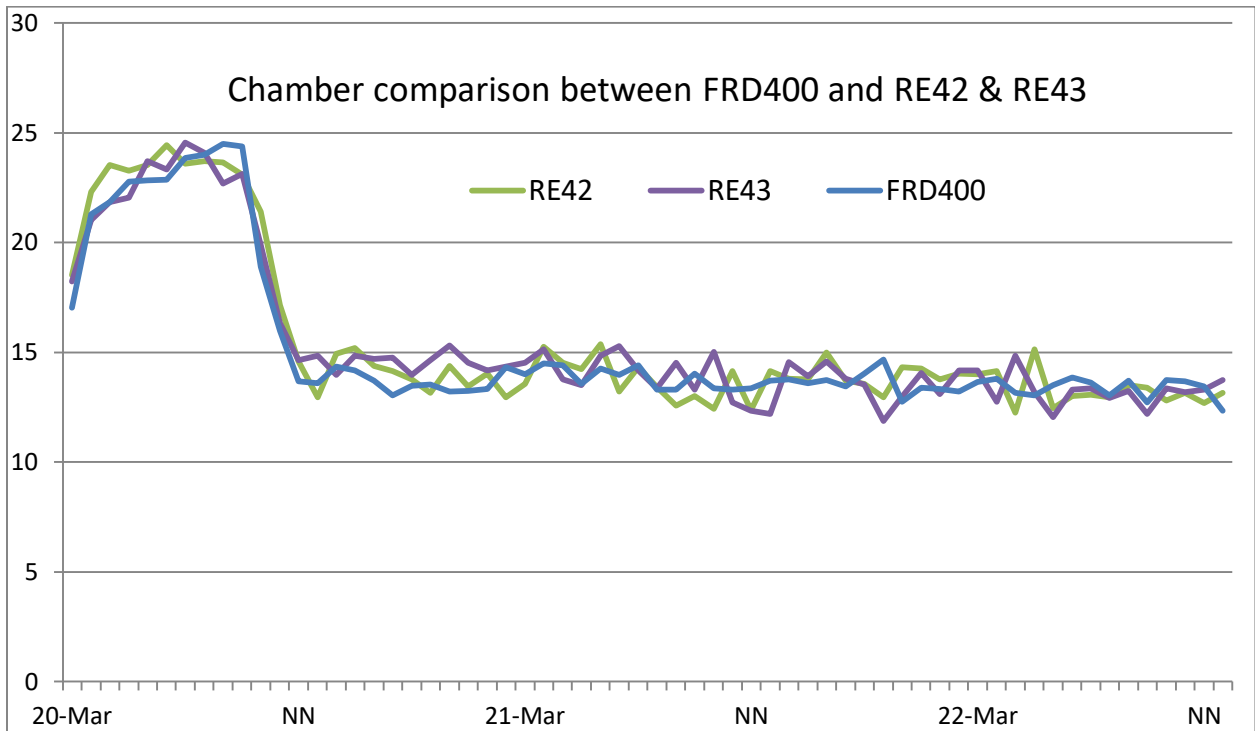
Figure 3: RE42 & RE43 Compared to FRD400

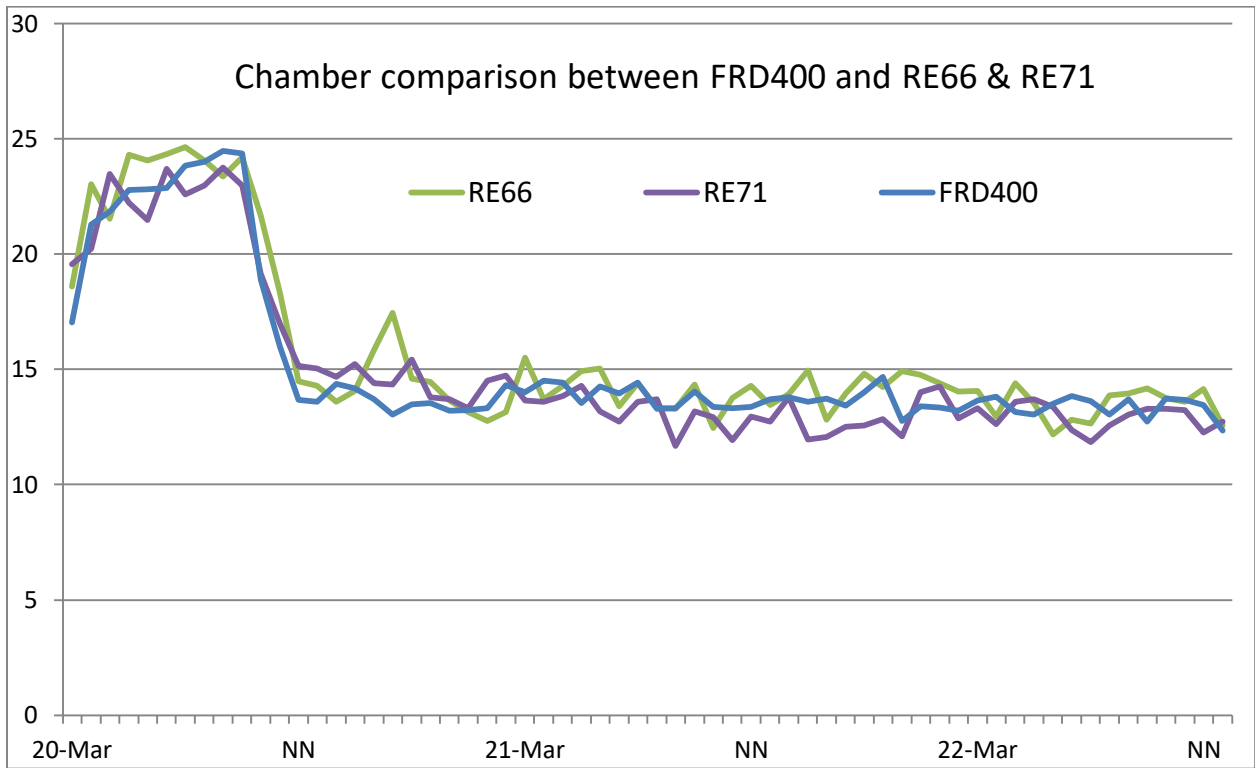
Figure 5: RE66 & RE71 Compared to FRD400

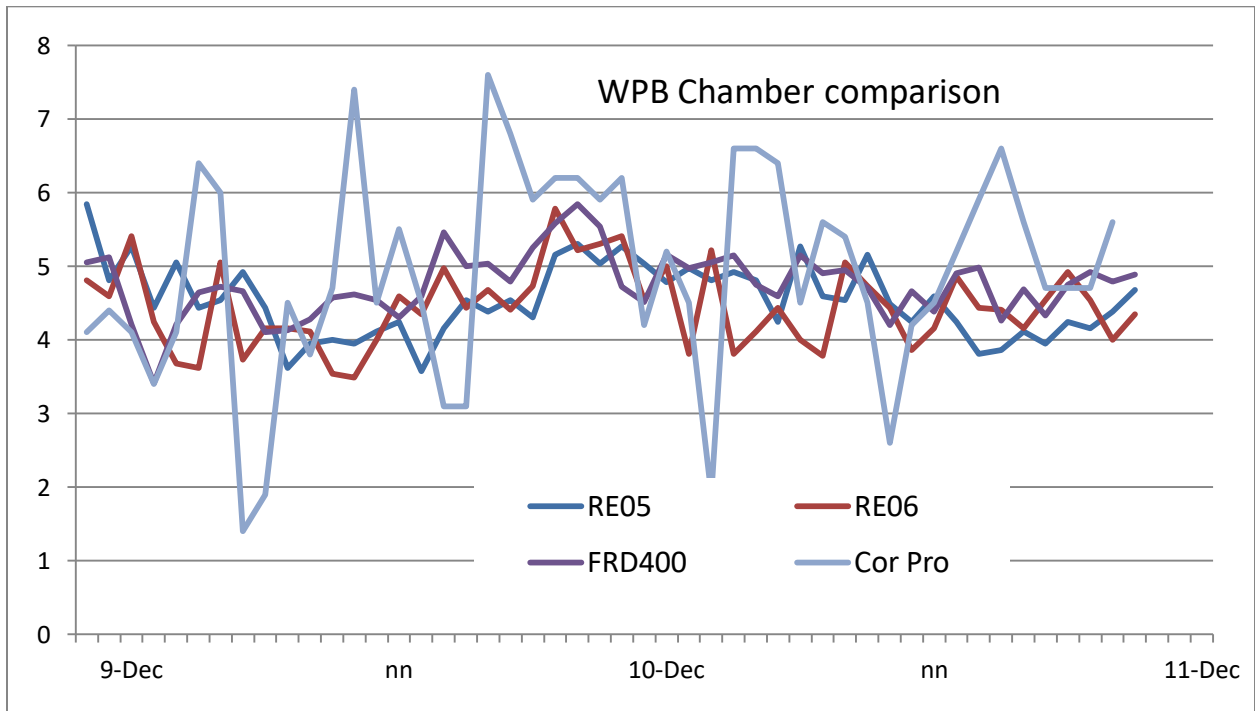
Figure 6: Corentium Pro Compared to FRD400

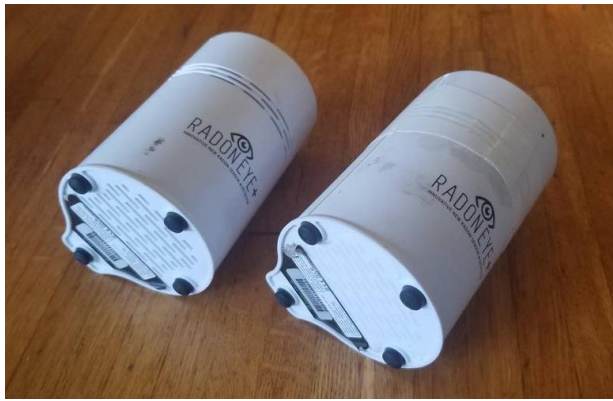
Initial radon measurements of the radon in the system exhaust were made with a RAD7. The RAD7 was set to sniff mode and used to measure the radon levels and the thoron levels in the system exhaust. The RAD7 measured about 226 pCi/l (8360 Bq/m³) of thoron and 221 pCi/l (8180 Bq/m³) of radon. Normally thoron is not an issue because its half life is only 55 seconds and decays away before it reaches a radon monitor in a basement. But even airflow of only 20 CFM (9.4 L/S) in a 4" (100mm) pipe is about 229 feet per minute (1.16 m/sec) which means it moves from soil to exhaust location in seconds. Continuous radon monitors (CRM) have different sensitivities to thoron depending on how long it takes for the thoron to diffuse into the detectors chamber. Previous testing by the author revealed that the Radon Eye might record as much as half of the thoron level as being radon. Slowing the entry of thoron into the detector would minimize this factor and not reduce the detectors ability to record the hourly radon average. The corentium pro was tested as having about 2.5% of the thoron exposure level recorded as being radon. The slotted openings to the Corentium Pro were sealed with a 6 mil vinyl tape used to seal crawl space membranes. This reduced the thoron response to 0.7%. When the Radon Eye RD200 plus had its slotted openings taped as illustrated in Figure 7, the thoron response was reduced to about 2% to 3% of the thoron level. All of the Radon Eye monitors used around the radon system exhaust outside had their slotted openings taped. This slows down the response time of the Radon Eye but does not change the hourly radon measurements.

Figure 7: Radon Eye un-taped and taped to delay thoron entry

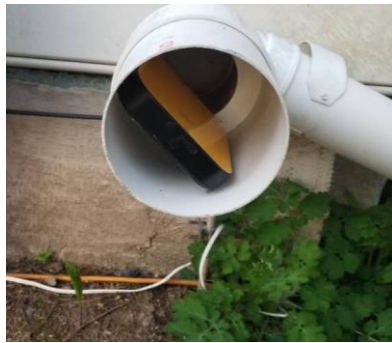
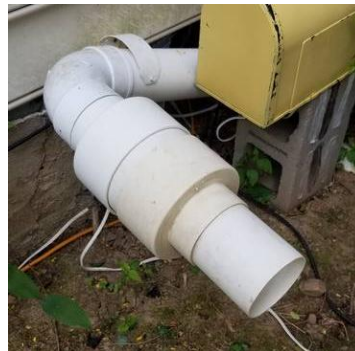
In order to quantify the radon continuously in the exhaust, two 4X6 adaptors were installed on the exhaust outlet with a short piece of 6" pipe between them. See Figure 8. This allowed the Corentium Pro to be installed in the piping to obtain hourly radon measurements. The radon level in the exhaust was measured when the airflow was varied from 20 CFM to 40 CFM to 69 CFM. (9.4 L/S, 18.8 L/S, 32.4 L/S)

Figure 8: Corentium Pro installed in exhaust piping

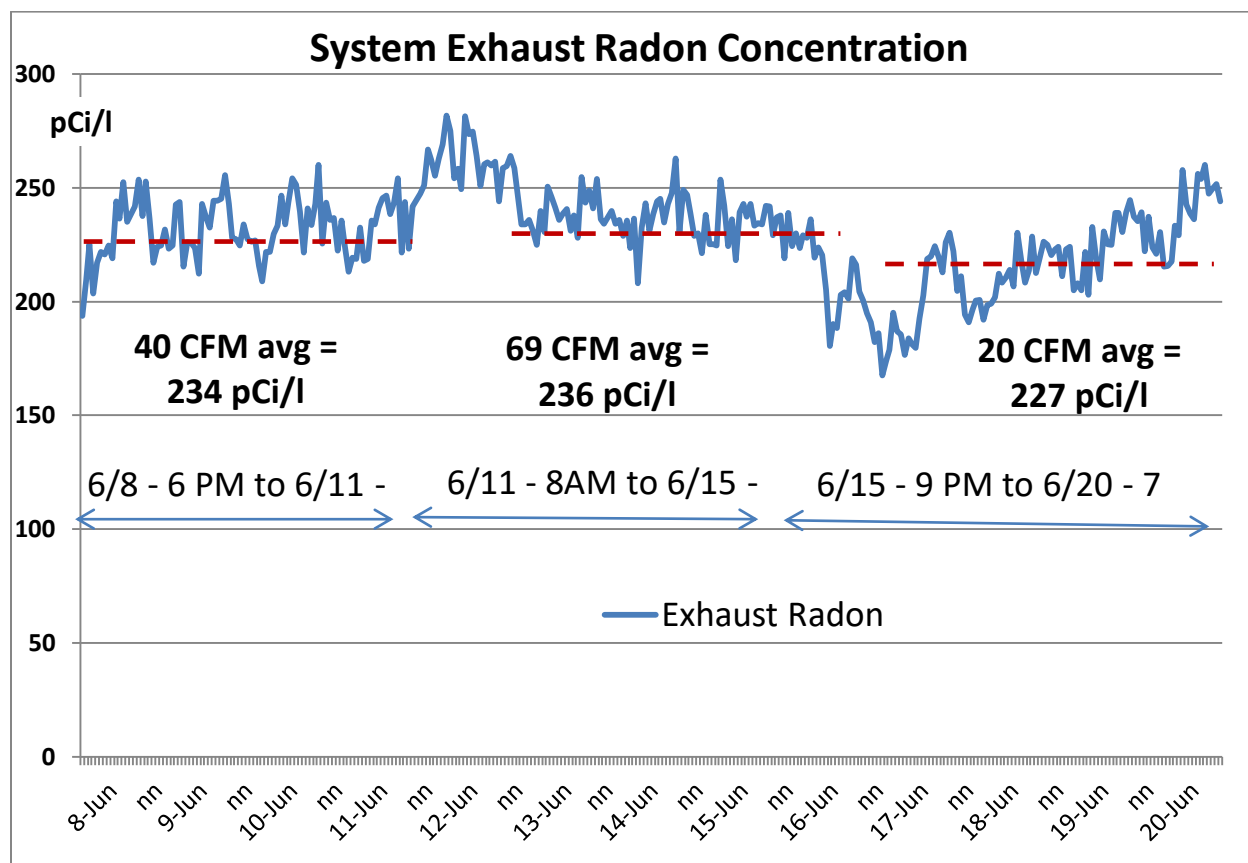
The average radon concentration in the pipe varied from 227 pCi/l at 20 CFM to 234 and 236 pCi/l at 40 and 69 CFM airflow. See Figure 9. The consistence is likely due to the lack of stone base under the slab in combination with three center suction pits and permeable sub-slab soil. If the system was drawing air out of the basement then higher airflow would likely induce lower exhaust radon concentration. The minimal variation in exhaust radon levels indicates there is not any significant dilution of soil gas with basement air at higher system vacuum and system airflow.

Figure 9: Radon level of System Exhaust

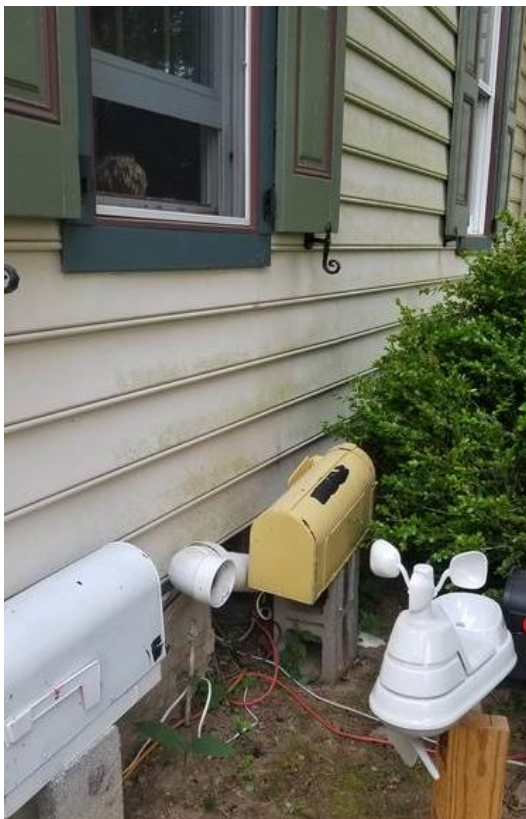
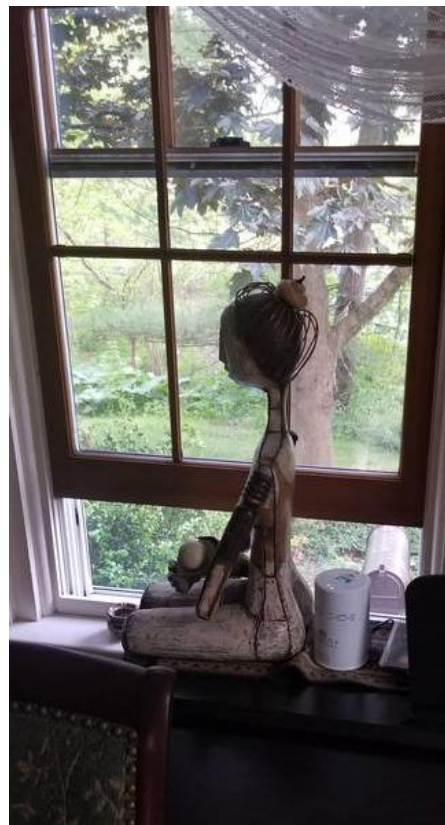
Prior to running the system exhaust outdoor diffusion measurements, six test runs were made that each had durations of five to seven days. Different CRM set-ups and placements were tried. During these initial test runs the CRM's outside were protected from rain by placing them in plastic mailboxes that had large holes drilled in the bottom of the mailbox. The system exhaust pipe size for four of the initial six tests was a four inch 90 degree elbow placed against the building siding at the rim joist location to simulate a typical at-grade system exhaust location. The other two tests were done with the exhaust port restricted to a 3" PVC pipe. The exhaust location was located under a window. See Figure 10.

During five of the test runs two of the CRM's were placed about 18" (0.5 meters) from the exhaust outlet on either side of the exhaust location. See Figure 10. The average of these two CRM's inside the mail boxes for the five runs was 0.68 pCi/l to 0.99 pCi/l (25 to 37 Bq/m³) greater than backyard ambient radon levels. On one of the test runs the average of the side detectors was 1.45 pCi/l (54 Bq/m³) above backyard ambient radon levels. The total average of the initial six tests was about 0.4% of the exhaust concentration of about 235 pCi/l (8700 Bq/m³). These side detector measurements were slightly higher than the latter exhaust diffusion test total average of 0.5 pCi/l above background

Figure 10: System exhausting 225 pCi/l at 40 CFM

During all the radon diffusion study test runs a CRM was placed indoors at the window above the exhaust. See Figure 10. During five of the test runs the window was closed with the radon system exhausting either 20, or 40 or 69 CFM of airflow. In all five of these tests the indoor CRM at the closed window measured averaged levels that were almost identical to a CRM on the same 1st floor about 20 feet away (6.5 meters) in the kitchen. This indicates there was no measureable re-entrainment during these tests. In one of the study test runs with the radon system exhausting 40 CFM, a window was left open for the entire 5 days of the exposure. See open detector and window in Figure 10. In this run the radon level average at the window was 0.4 pCi/l (15 Bq/m³) greater than the kitchen CRM (1.26 pCi/l versus kitchen 0.85 pCi/l). See the results graphed in Figure 11.

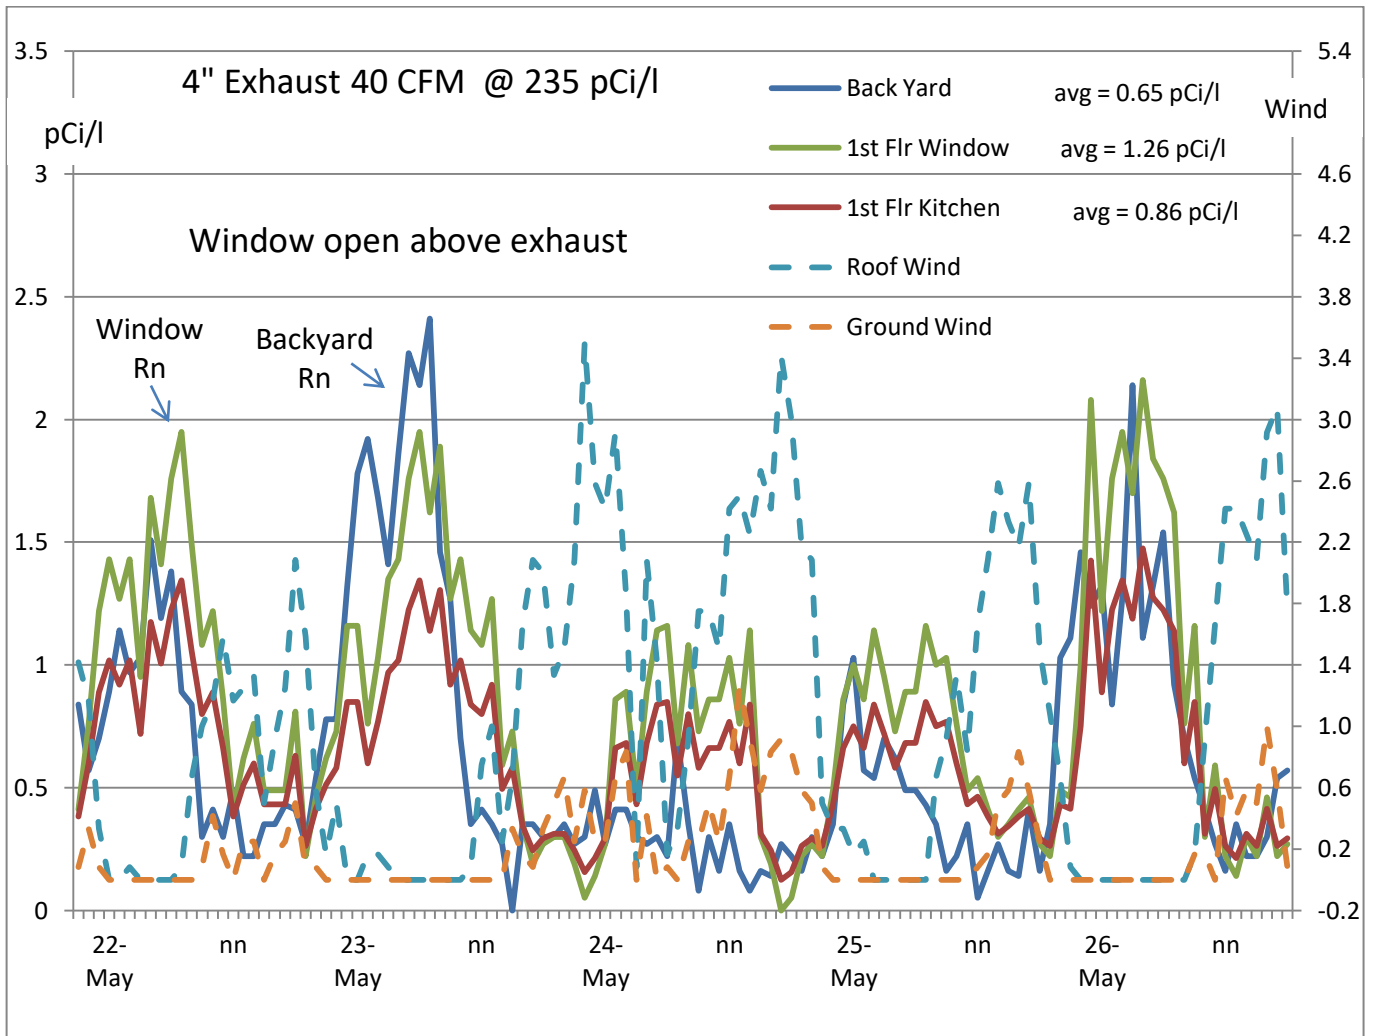
What did cause indoor radon levels to measurably increase was the outdoor radon levels during windless periods. See Figure 11 which shows the outdoor radon levels climbing to 2.0 pCi/l and the indoor radon levels climbing above 1.0 pCi/l from their apparent baseline of 0.5 pCi/l.

Figure 11: System exhausting 235 pCi/l at 40 CFM with window open

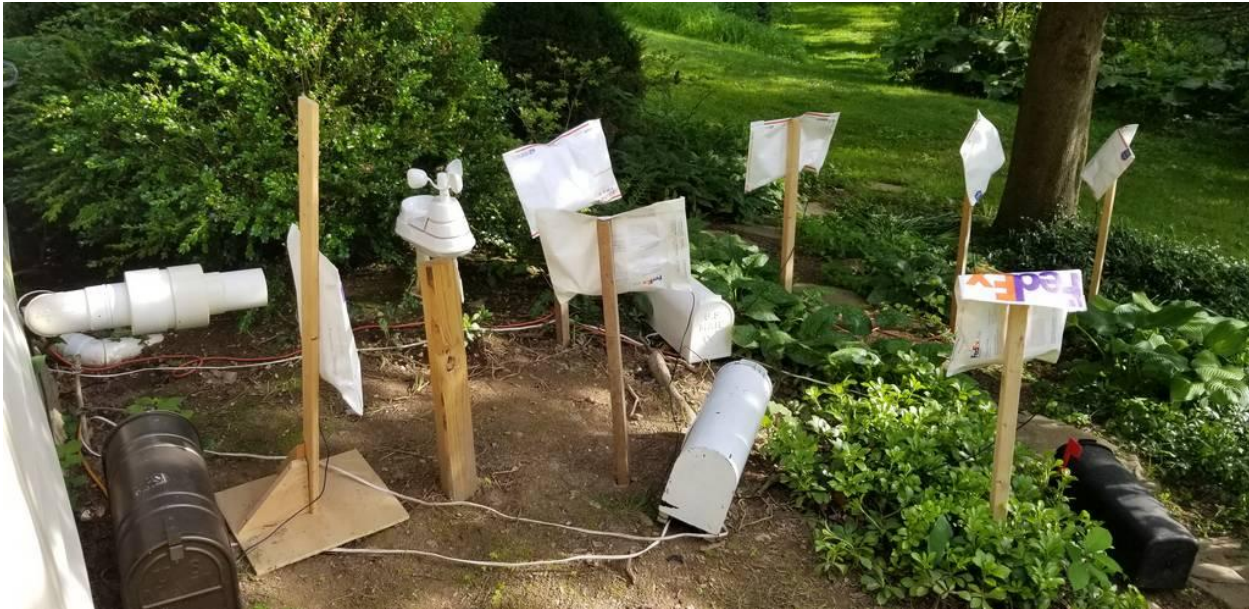
Figure 12: CRM and weather station placement in ASD exhaust stream

Figure 12 displays the placement of the CRM's that were protected in Tyvek envelopes and mounted to wood stakes. The chargers for the CRM's were placed in plastic mailboxes on the ground. The farthest CRM in direct alignment with the exhaust is four meters (13 feet) away from the outlet. The furthest CRM placed at a 45 degree angle to the exhaust is three meters (9.75 feet) away from the outlet. This CRM is not visible in the photo in Figure 12. There is one CRM that is 0.5 meters (19.5 inches) to the side of the exhaust location. A ninth CRM is 40 feet away from the exhaust on a picnic table in the backyard of the residence. The six inch, 200 mm, piping was used to place a corentium pro CRM inside the exhaust stream to measure the radon levels in the exhaust continuously.

when the exhaust outlet was farther from the siding to accommodate the exhaust measurement detector and the detectors were placed inside tyvek envelopes. See Figure 12.

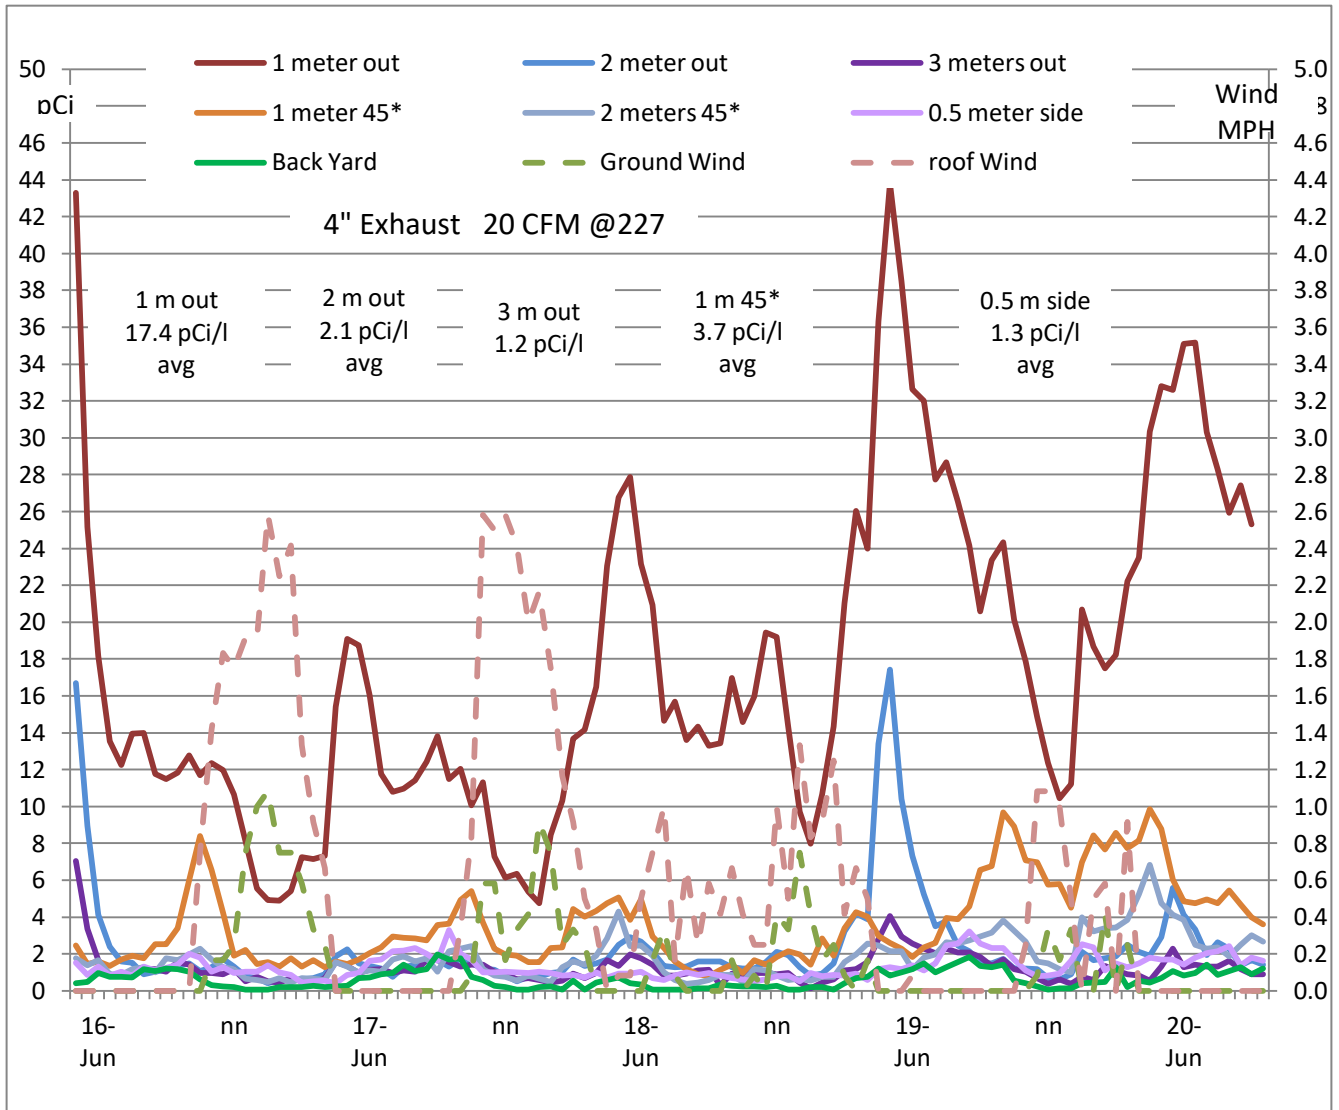
Figure 15 depicts the same 20 CFM (9.4 L/s) flow but with a 4 inch exhaust outlet that has an exit flow rate of 229 feet per minute (1.16 M/S) compared to a flow rate of 407 FPM (2.06 M/S). The red line depicting the radon levels at 1.0 meter in direct line with the exhaust is peaking at about 18 pCi/l (666 Bq/m³) to about 42 pCi/l (1554 Bq/m³). The range of variation is similar to the previous discussed run at 20 CFM (9.4 L/s) using a 3 inch orifice. Once again the CRM at 1.0 meter at a 45 degree angle tends to peak just as the weather station starts to record some wind speed. The pink and green lines representing the backyard and side exhaust CRMs again track each other with the side exhaust averaging slightly higher at 1.30 pCi/l (48 Bq/m³) than the backyard average of 0.61 pCi/l (23 Bq/m³) which is an average difference of 0.69 pCi/l (25 Bq/m³) for the entire four days of testing. The average level of the five CRM monitors included in the chart are very similar to the averages displayed in the Figure 14 chart with the 3 inch exhaust pipe.

The CRM at 2.0 meters in direct exhaust alignment in Figure 15 did have one spike to 16 pCi/l (592 Bq/m³) during the longest windless periods versus only spiking to 2.0 pCi/l to 4.0 pCi/l during the shorter windless periods. The previous test in Figure 14 had multiple spikes at 2.0 meters to 8.0 pCi/l (296 Bq/m³) which appears due to the higher airflow velocity induced by the 3 inch orifice. The additional possible reason for this single 16 pCi/l spike may be a heavy rainfall of about 1.5 inches from 3 PM until midnight although the following night at almost similar spike. In general the CRM placed 2.0 meters in line with the exhaust had lower radon levels using the 4 inch exhaust than the 3 inch outlet. The overall average of the 3 inch orifice at 2.0 meters was 2.6 pCi/l (96 Bq/m³) versus 2.1 pCi/l (78 Bq/m³) average for the 4 inch orifice which does include the one rain induced spike. If the average radon results for the 4 inch orifice included the radon levels of the other windless period and not the one rain spike, the overall average would be 1.76 pCi/l.

Figure 15: Four inch exhaust at 20 CFM and 227 pCi/l (8400 Bq/m³)

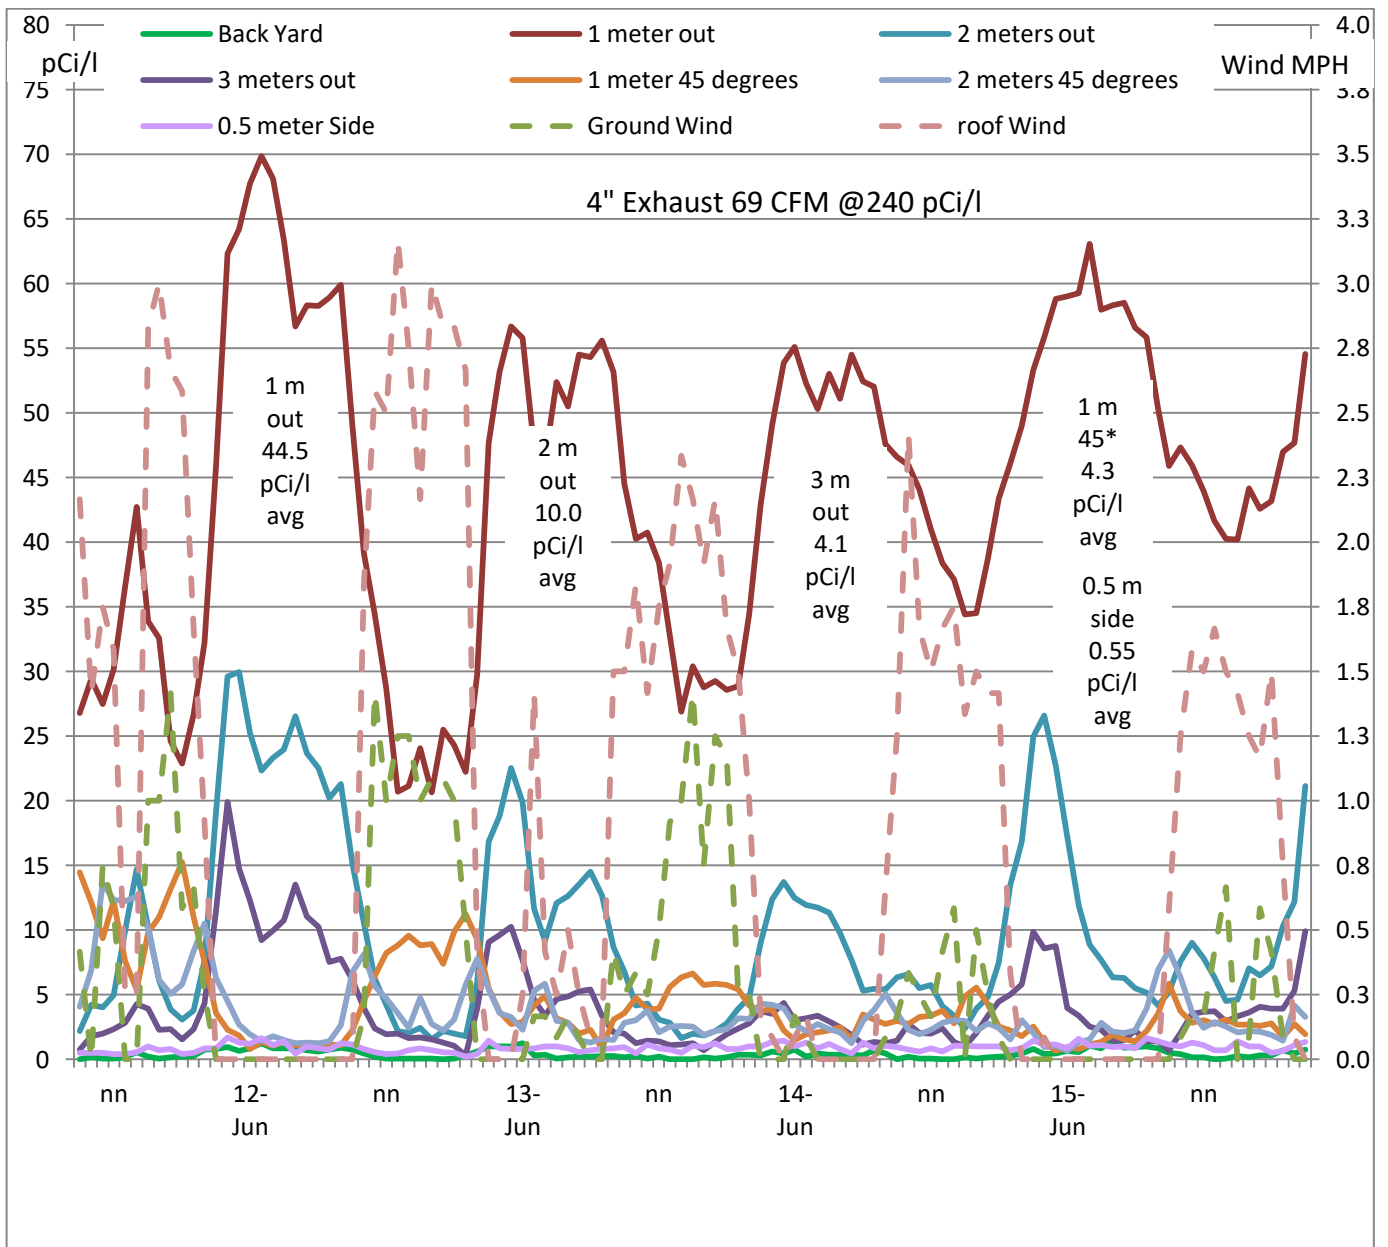
Figure 19 depicts the 69 CFM (32.6 L/s) with a 4 inch (100 mm) exhaust outlet that has a flow rate of 790 feet per minute (4.01 m/s). In this run the red line depicting the radon levels at 1.0 meter in direct line with the exhaust is peaking during windless periods at radon levels ranging from about 55 pCi/l (2035 Bq/m³) to about 60 pCi/l (2220 Bq/m³). This is a slightly higher peak range than was measured when the 4 inch exhaust was at 40 CFM (18.9 L/s). Exhaust velocity increase from 458 feet per minute (2.33 m/s) to 790 feet per minute (4.01 m/s) did not significantly increase radon peak levels measured at 1.0 meter in the path of the exhaust. The averages at 2.0 meters and 3.0 meters in direct line of the exhaust averaged slightly higher than the average at 40 CFM (18.9 L/s). The radon levels at 0.5 meters to the side of the exhaust of 0.51 pCi/l higher than background did measure slightly lower at the higher 69 CFM velocity. All the averages of each run are listed in Table 2 for direct comparison. The averages are obviously influenced by quantity of non wind versus wind periods.

69 CFM flow with 4" exhaust orifice

Figure 19: Four inch exhaust at 63 CFM and 236 pCi/l (8730 Bq/m³)
